**420 EAST 3<sup>RD</sup> STREET DEVELOPMENT**  
PITTSBURG, CALIFORNIA

**GEOTECHNICAL FEASIBILITY EVALUATION**

April 1, 2021

**PROJECT NO.**  
18562.000.001

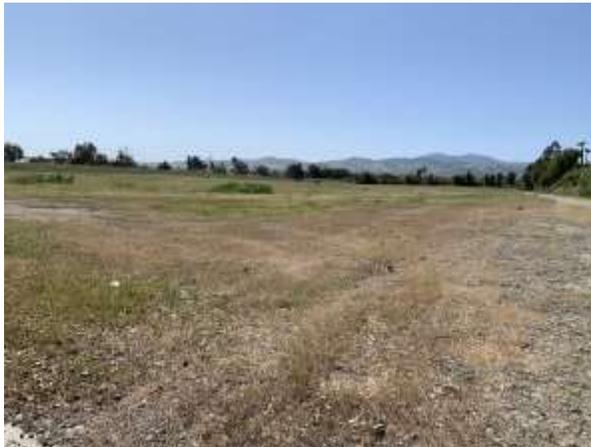
We performed a reconnaissance of the site on March 29, 2021, to observe current site conditions. The site is currently vacant and is secured by a perimeter fence on all sides. The site consists of relatively level, vegetated open space.

**PHOTO 2.2-1: Northern Area of Site (facing South)**

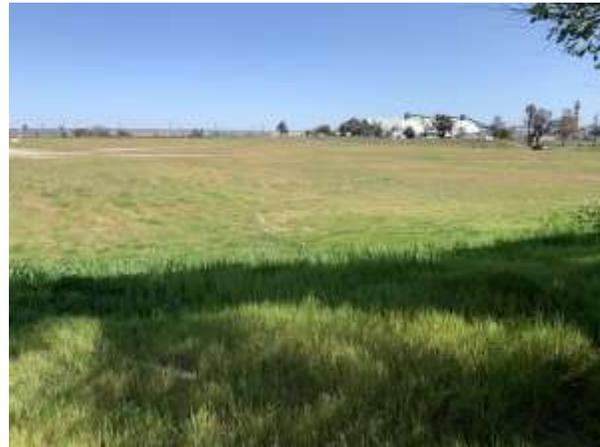
**PHOTO 2.2-2: Southern Area of Site (facing North)**

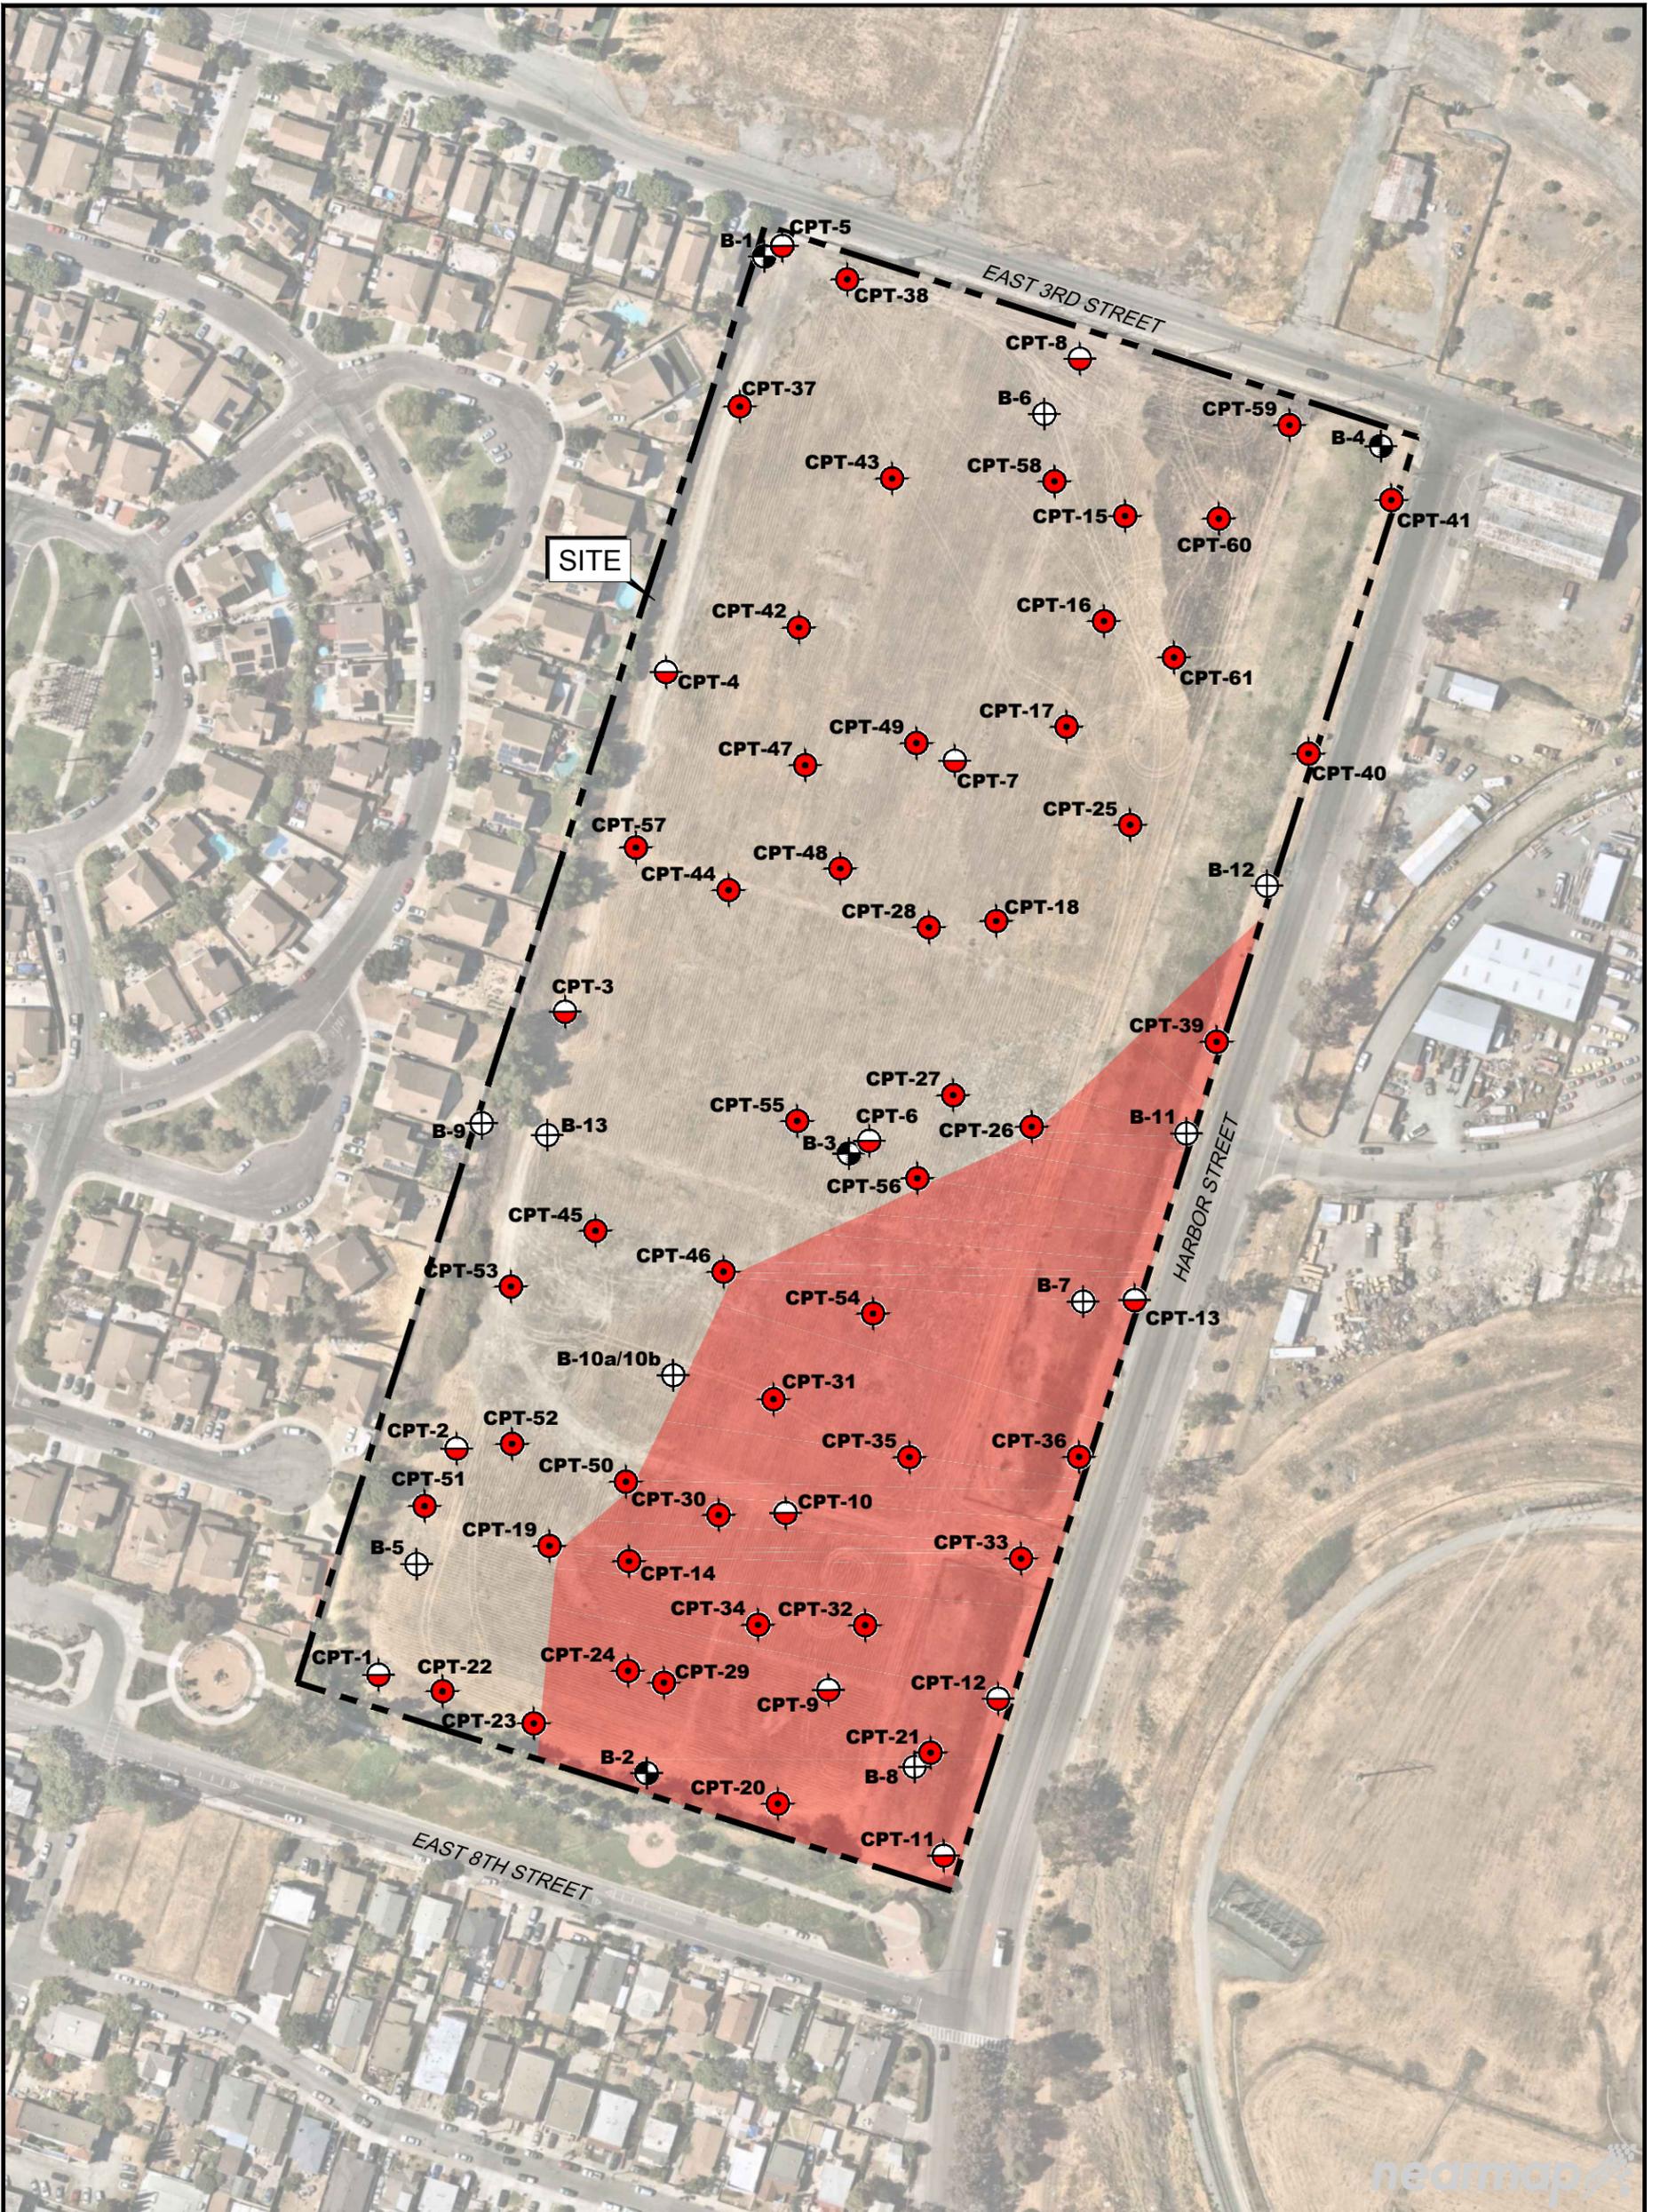
The site was explored in 2005 and again in 2006 by Treadwell and Rollo (T&R) with a total of 61 cone penetration tests (CPTs) and 13 drilled borings throughout the site. Locations of the borings and CPTs locations are presented in Figure 2.

The previous borings ranged in depth between 19 and 51½ feet and the CPTs ranged in depth between 30 and 50 feet. The exploration logs and associated laboratory testing results from the 2005 and 2006 exploration are included in Appendix A.
