# PRELIMINARY GEOTECHNICAL RECONNAISSANCE

MONTREUX SUBDIVISION 8279 PITTSBURG, CALIFORNIA

Prepared by: ENGEO Incorporated

February 16, 2011 Project No. 5469.200.200

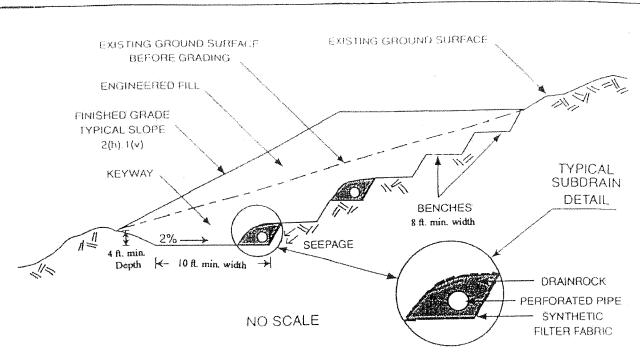
KLEI	NFELDER	Typical Keyway, Bench and Subdrain Detail  Proposed Montruex Subdivision	2
Drawn By:	Dale:	Kirker Pass Road	3
Project No. 43-1131-01.GEO	Fllename:	Pittsburg, California

#### NOTES

- Benches should be sloped about two percent (2%) away from the natural slope to facilitate drainage of the fill embankment. Benches and keyway should be excavated to competent subgrade as evaluated by the project Geotechnical Engineer during construction.

- f) Pipe drainage should be collected in a solid conduit and directed to a storm drain, ditch, or other suitable location for disposal.
  - 9) Perforated pipe should be sloped a minimum of two percent (2%) to drain.

height, whichever is greater; with the bottom inclined down and back into the slope at 2 percent. As filling progresses, benches should also be cut into firm competent soil/weathered rock. Each bench should consist of a level terrace at least 8-feet wide with the rise to the next bench held to 5 feet or less. Subsurface drainage should be also placed within the toe keyway and at the midpoint of the slope. A typical keyway, bench and subdrain detail is presented on Plate 3. Fill slopes should be constructed by overfilling and trimming back to provide a firm, well compacted slope face.

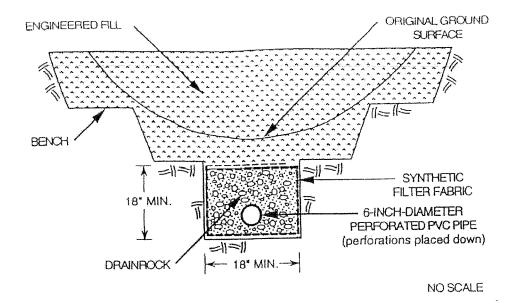
#### NOTES:

- 1. Subdrain should be excavated into competent subgrade as evaluated by the project Geotechnical Engineer during construction.
- 2. Surfaces to receive filter fabric should be free of loose or extraneous material and sharp objects that might damage the filter fabric during installation.

General subdrain details are presented on Plate 5. Prior to placement of the subdrain, the drainage channels should be cleaned of all organics, organic soils, and disturbed material to firm native subgrade and benched with sides sloped 2(h):1(v) or flatter to permit access for compaction equipment.
